WILDFIRE SMOKE AND ITS IMPACT ON THE INDOOR AIR QUALITY AROUND METRO VANCOUVER

Metro Vancouver, B.C.

November 9, 2020

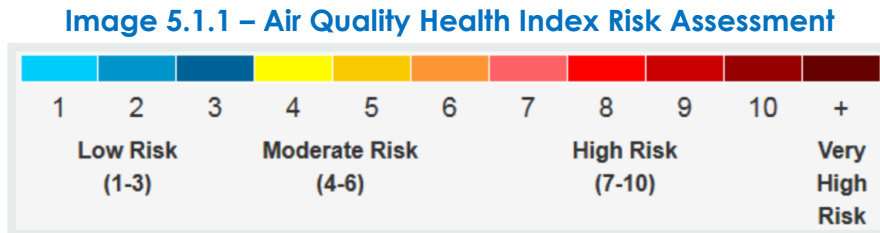
Environment and Climate Change Canada archives historical weather data, forecast and current conditions graphics that can be found online. According to **Image 5.1.1** courtesy of Environment and Climate Change Canada, an Air Quality Health Index (AQHI) can be read as followed:

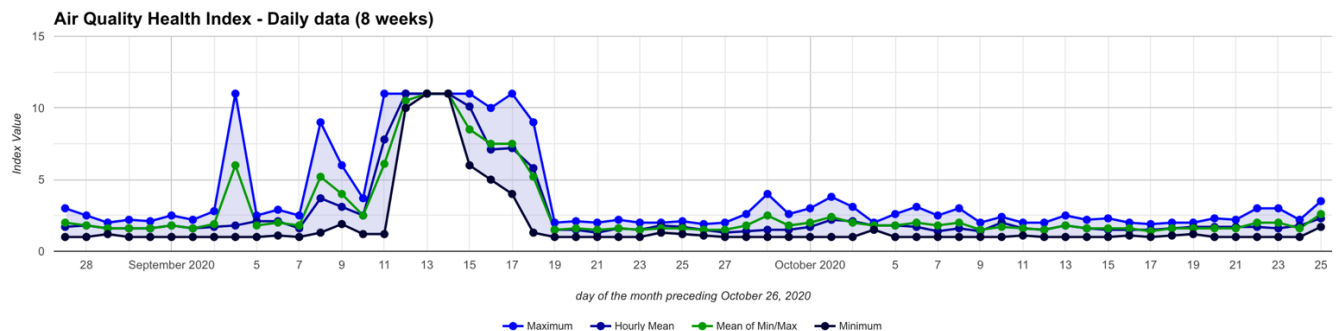
**Image 5.1.2 – Air Quality Index (Metro Vancouver Area)
September – October 2020**

Image 5.1.2 below was acquired from https://vancouver.weatherstats.ca/charts/health_index-daily.html and presents the outdoor AQHI for Metro Vancouver in the months of September and October in 2020.

Based on **Image 5.1.2** and **Table 5.1.1 (next page)**, the following was deduced and applied only to Metro Vancouver:

- AQHI generally remains consistent at around 2, when we exclude extremes, and this is classified as low risk
- An AQHI of 3.7 was reached on September 10, 2020 (Building A)
- An AQHI of 11 was reached on September 11, 2020 (Building B)
- An AQHI of 11 was reached on September 14, 2020 (Building C)
- An AQHI of 11 was reached on September 15, 2020 (Building D)
- An AQHI of 11 was reached on September 16, 2020 (Building E)
- An AQHI of 2 was reached on September 23, 2020 (Building F)
- An AQHI of 2.6 was reached on October 5, 2020 (Building G)
- An AQHI of 3.1 was reached on on October 6, 2020 (Building H)
